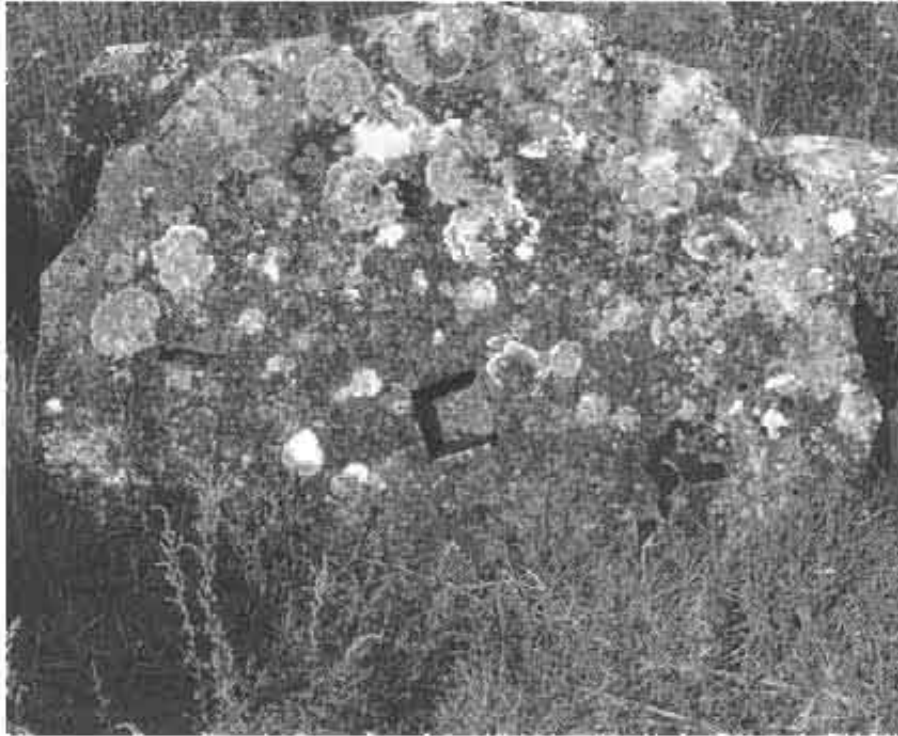
Block 492.

492. Column drum. Bottom surface half visible (1 dowel and empolion hole), top almost complete. Top faces E. 14 flutes. Pres. c. 9/10. (=D51) Pos: D. Diam_L: 1.321 (1.318–1.324). Diam_T: 1.268 (1.266–1.270). H: 1.448 (1.446–1.450). FIW_L: 0.215–0.217. FIW_T: 0.209. Diam_{UA}: 1.335. C: Top arris, E end. X: -27.11 Y: -7.12 Z: -0.37

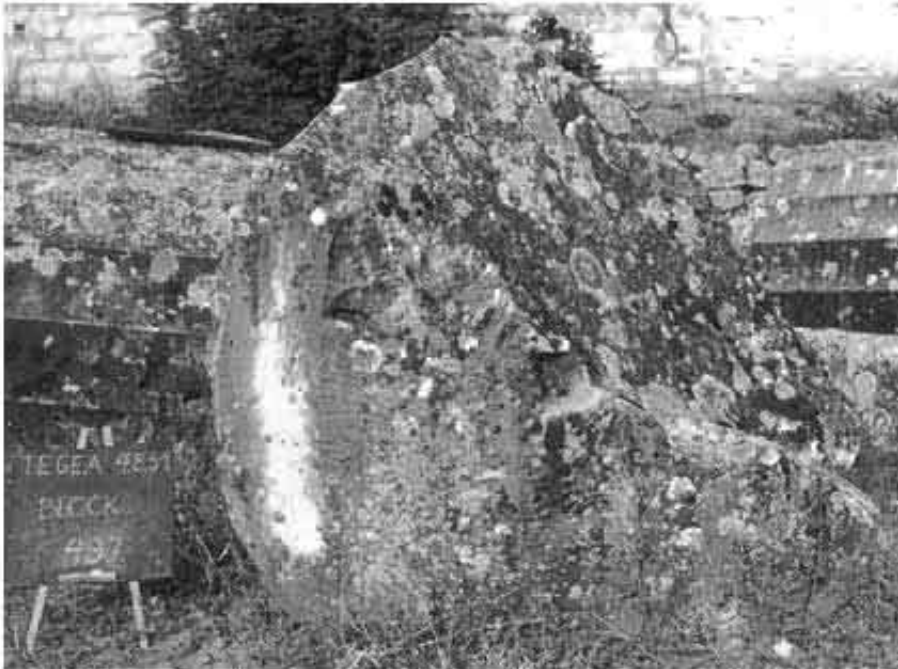
Block 497.

497. Column drum. Both surfaces badly broken, but measurements possible to take (both with 1 dowel and empolion hole). Top surface faces E. 8 flutes visible. Pres. c. 2/3.

Pos: E. Diam_T: 1.268 (1.265–1.271). Diam_U: 1.218 (1.215–1.221). H: 1.347 (1.344–1.350). FIW_L: 0.208. FIW_T: 0.198.
C: Empolion. X: -22.55 Y: -3.00 Z: -0.85

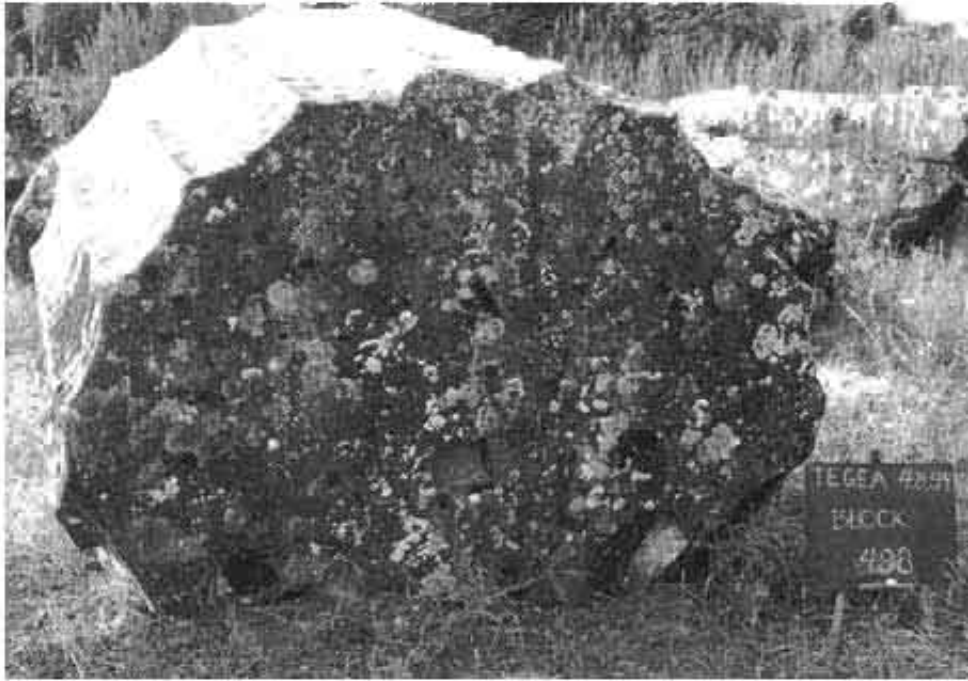
Block 498.

498. Column drum. Top surface less than half preserved, bottom more than half. Both with empolion and 1 dowel hole. Bottom faces N. 13 flutes visible. Pres. c. 4/5.

Pos: B. Diam_L: 1.420 (1.417–1.423). Diam_T: 1.370 (1.367–1.373). H: 1.484 (1.481–1.486). FIWL: 0.233–0.235. FIWT: 0.227–0.235. Diam_{LA}: 1.478.

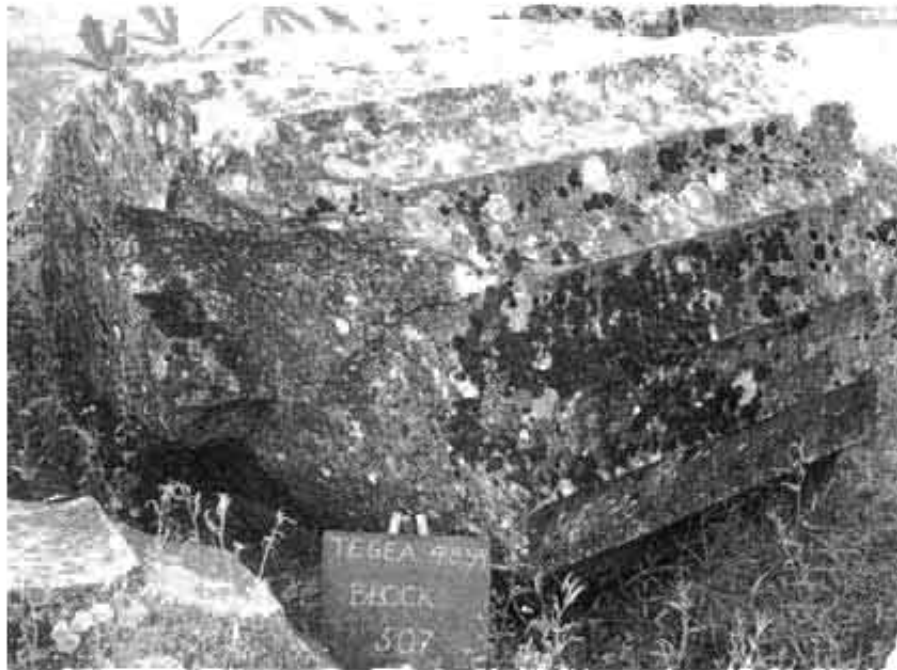
**Block 507.**

507. Column drum. Top surface well preserved (with only empolion; top drum), bottom mostly broken (no holes). Top faces SW.

Probably 20 flutes. Pres. c. 4/5.

(=D53) Pos: F. Diam_L: 1.206 (1.202–1.210). Diam_T: 1.155 (1.152–1.158). H: 1.349 (1.343–1.353). FIWL: 0.199–0.200. FIWT: 0.190–0.191. C: Bottom of the top flute, NE edge. X: -29.48 Y: -2.45 Z: -0.37

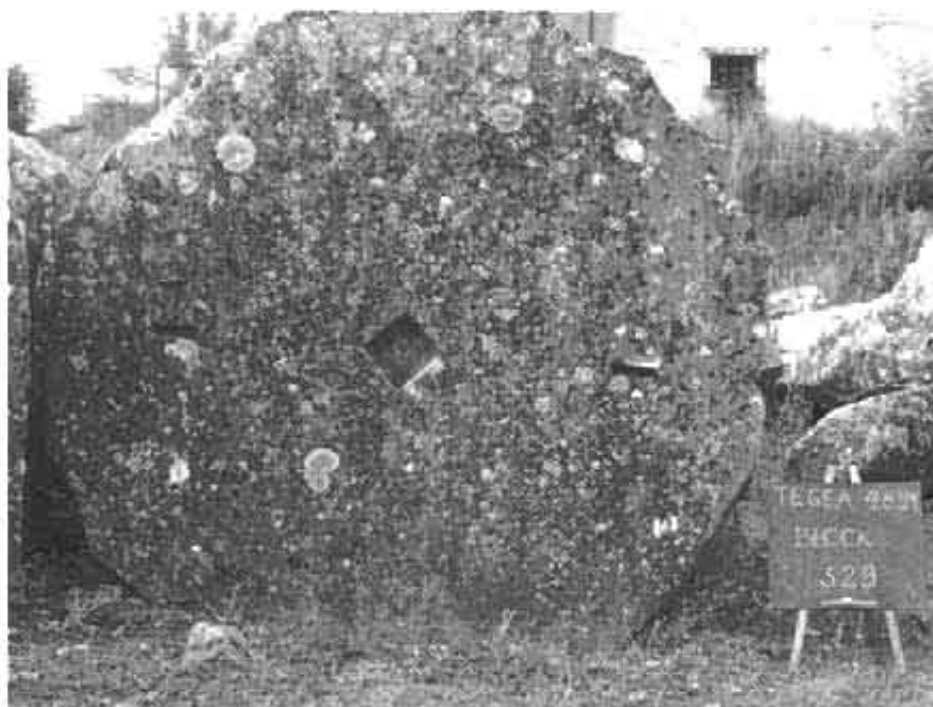
Block 529.

529. Column drum. Bottom surface almost complete, a small segment broken off the top surface. Both with empolion and 2 dowel holes. Bottom surface faces N. Apparently 20 flutes. Pres. c. 1/1.
Pos: B. Diam_L: 1.418 (1.416–1.420). Diam_V: 1.376 (1.374–1.378). H: 1.473 (1.470–1.475). FIW_L: 0.232–0.234. FIW_V: 0.226–0.228. Diam_{LA}: 1.490. Diam_{VA}: 1.445.
C: Bottom of the top flute, N edge. X: -15.40 Y: 3.35 Z: -0.06

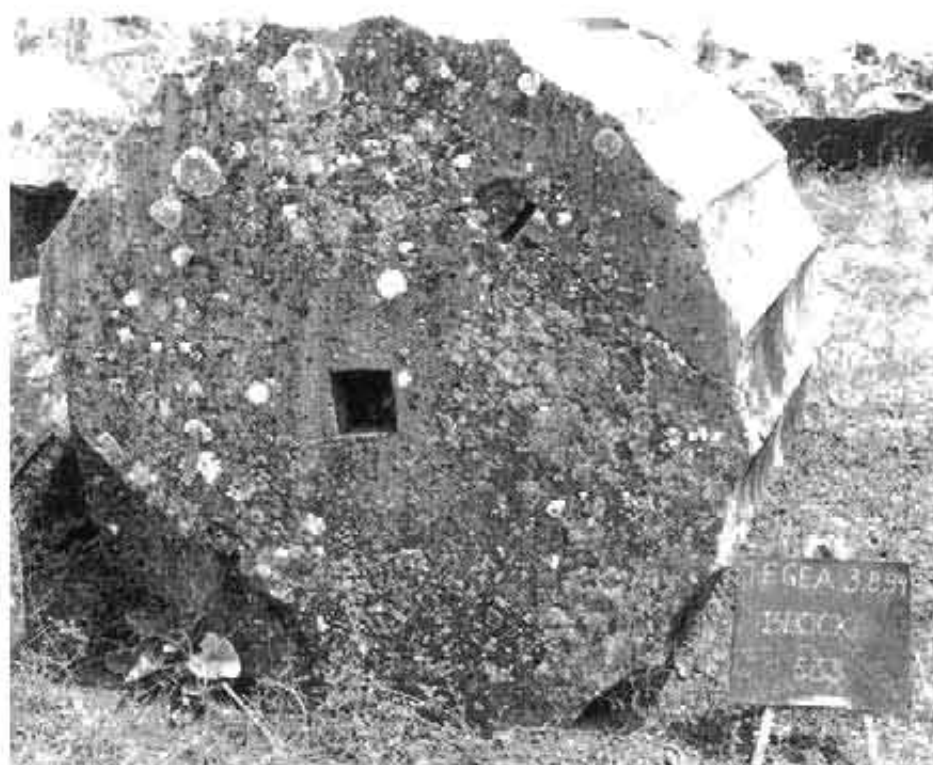
Block 533.

533. Column drum. Edges of the top surface broken, a small segment broken off the top surface. Both with 2 dowel holes and empolion (other dowel hole on bottom partially broken). Top faces SE. Apparently 20 flutes. Pres. c. 1/1.
Pos: E. Diam_L: 1.274 (1.272–1.276). Diam_V: 1.223 (1.221–1.225). H: 1.356 (1.354–1.358). FIW_L: 0.209–0.210. FIW_V: c. 0.200. Diam_{LA}: 1.339. Diam_{VA}: 1.280.
C: Bottom of the top flute, NW edge. X: -22.17 Y: 1.48 Z: -0.19

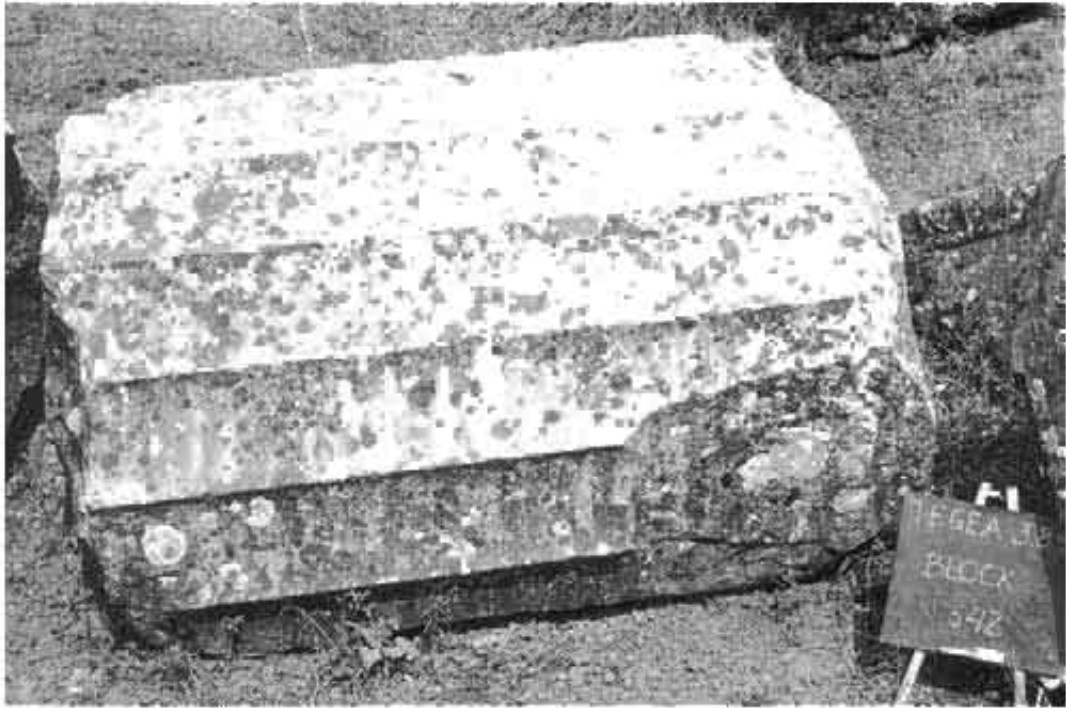
Block 542.

542. Column drum. Anathyrosis rim broken on both surfaces. Top surface with only empolion hole (top drum), bottom with 1 dowel and empolion hole. 11 flutes. Pres. c. 2/3.

(=D65) Pos: F. Diam_L: 1.220 (1.218–1.222). Diam_U: 1.154 (1.151–1.157). H: 1.500 (1.497–1.505). FlW_L: 0.198–0.201. FlW_U: 0.189–0.192. C: Bottom of the top flute, NW end. X: -22.43 Y: 3.45 Z: -0.74

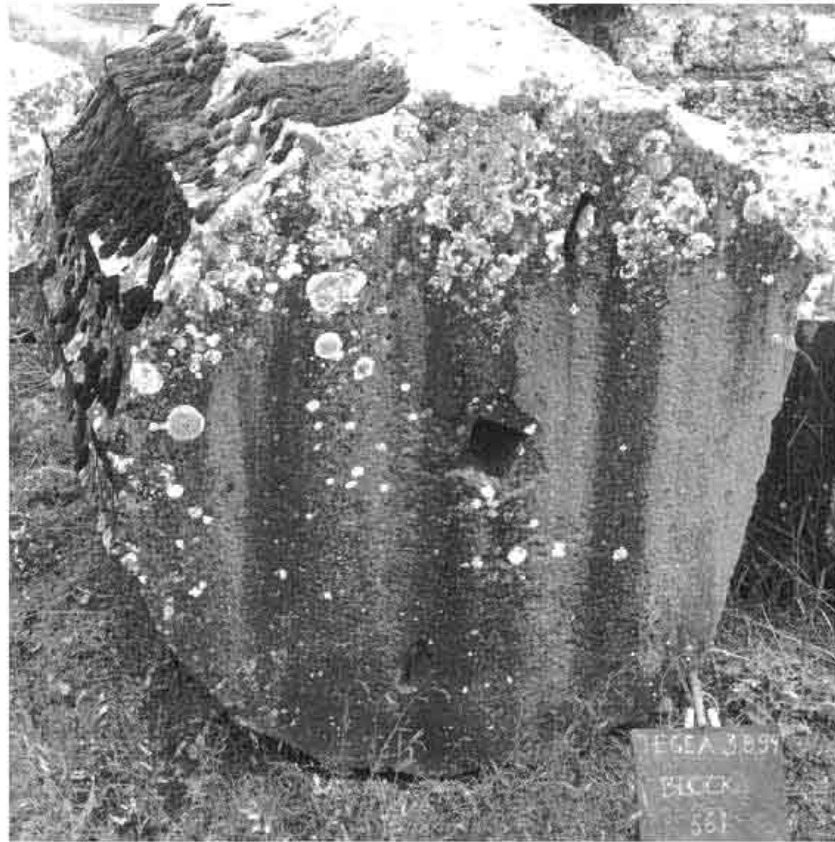
Block 561.

561. Column drum. A small segment broken off the top surface (empolion and 2 dowel holes), bottom badly broken (empolion and dowel hole). Top faces W. 16 flutes. Pres. c. 3/4.

Pos: B. Diam_L: 1.417 (1.414–1.420). Diam_U: 1.374 (1.371–1.377). H: 1.477 (1.475–1.479). FlW_L: 0.234. FlW_U: 0.226–0.227. Diam_{UA}: 1.447. C: On bottom of top flute, W end. X: -16.80 Y: 14.06 Z: -0.05

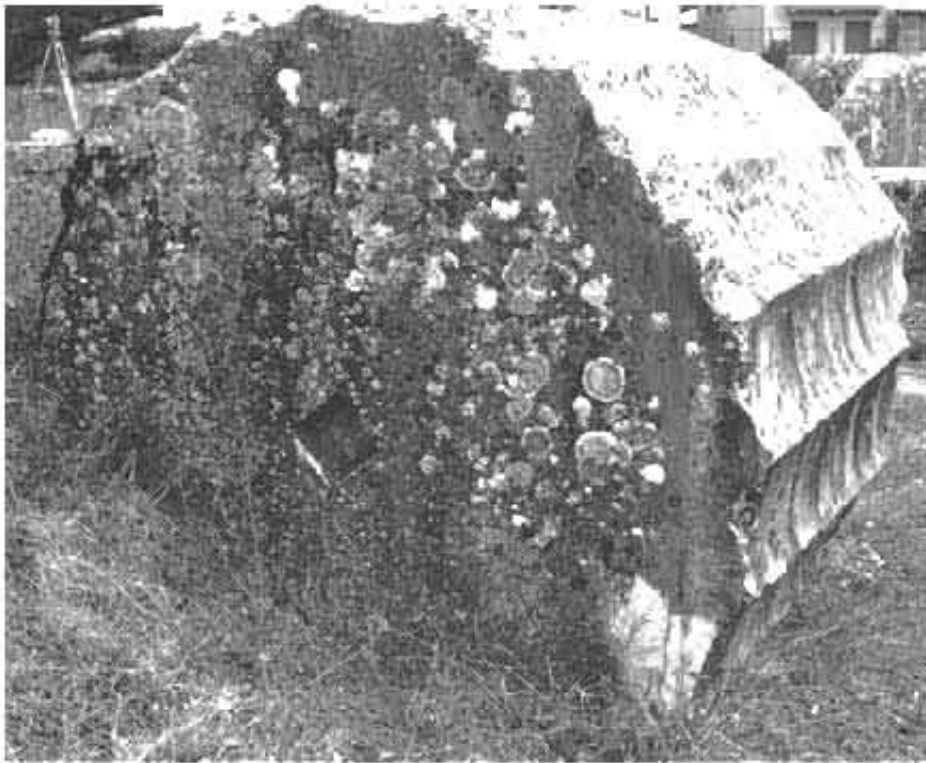
Block 564.

564. Column drum. Top surface one fourth buried, but apparently complete (empolion and dowel hole), edges of the bottom broken, otherwise complete (empolion and 2 dowel holes). Bottom faces SE. Probably 20 flutes. Pres. c. 1/1.

(=D71) Pos: A. Diam_L: 1.455 (1.452–1.458). Diam_T: 1.416 (1.413–1.419). H: 1.472 (1.469–1.474). FIW_L: –. FIW_T: 0.233–0.235. Diam_{LA}: 1.52. Diam_{TA}: 1.471.

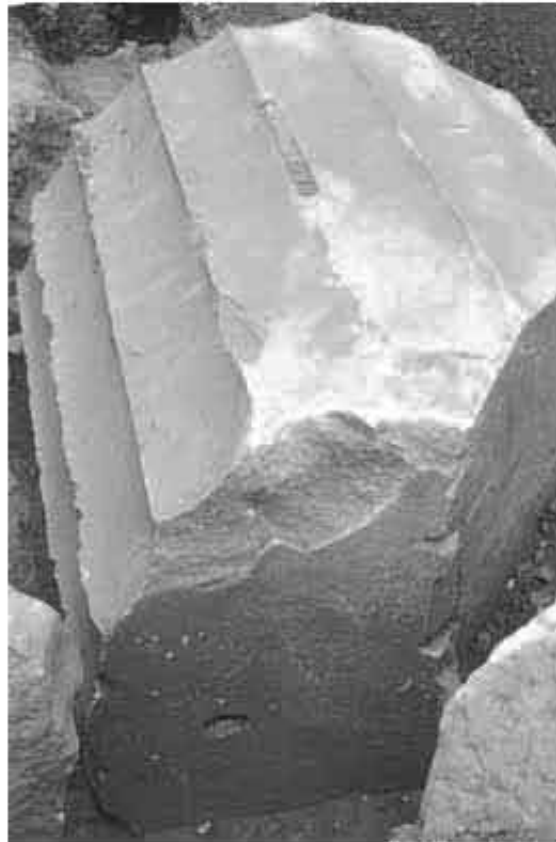
Block 809.

809. Column drum. Top surface one third buried but probably complete (empolion and 2 dowel holes). Bottom more than half broken with 1 dowel hole. Arris repaired on the top flute and also at the NE corner of the drum a rectangular cut for arris repair (see p. 29). 14 flutes. Pres. c. 4/5.

Pos: C. Diam_L: 1.365 (1.360–1.370). Diam_T: 1.332 (1.330–1.334). H: 1.457 (1.454–1.459). FIW_L: 0.226. FIW_T: 0.219–0.220. Diam_{TA}: 1.405. C: Bottom of the top flute, N end X: 19.41 Y: 22.31 Z: -1.07
